ESTCP Cost and Performance Report

(ER-200828)

Field Demonstration of Propane Bioparging for *In Situ* Remediation of N- Nitrosodimethylamine (NDMA) in Groundwater

December 2015

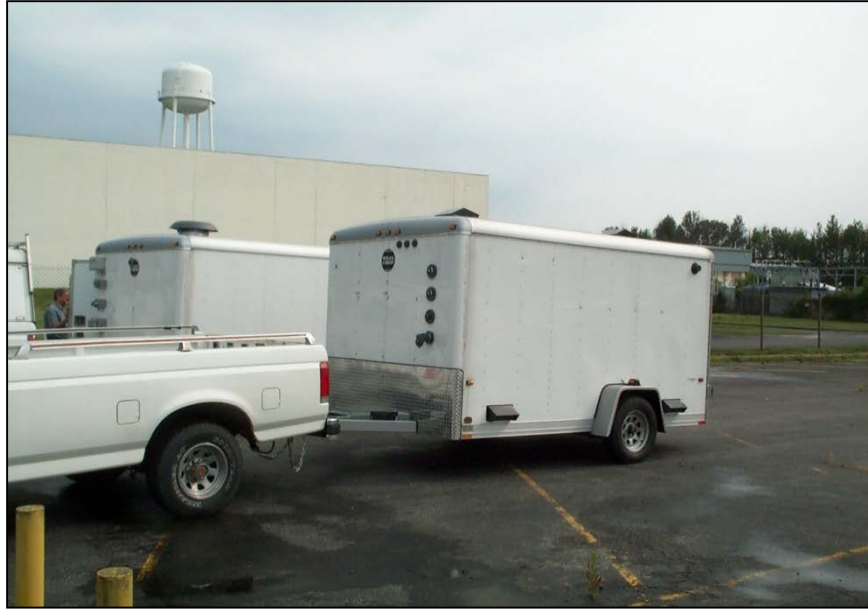
Figure 5.2. Biosparge Trailer Units.

CB&I refurbished an existing propane biosparging system for use during this demonstration. The trailers were shipped to CB&I's engineering and equipment facility in Findlay, OH, where all components were inspected, adjusted, or replaced as necessary to ensure good operation in the field. The system consists of two mobile trailers (Trailer #1 and Trailer #2) housing equipment and controls (**Figure 5.2**). Trailer #1 (**Figure 5.3**) is electrically wired for a non-explosion proof atmosphere. It contains the main control panel and main electrical junction box as well as the air feed system. A 220 volts alternating current (VAC), single-phase power drop to the system is required to be hard-wired to the main electrical junction box located on the outside of Trailer #1. A Programmable Logic Controller (PLC) and user interface are located within the trailer in the main control panel. Electrical power and control is transferred via flexible cable to Trailer #2. A wireless system was installed to provide for call out when an operating fault was detected. The air feed system included a two-stage, duplex air compressor with 5 horsepower (HP) motors and a 120 gallon tank, capable of providing 34.2 standard cubic feet per minute (SCFM) at 175 pounds per square inch (psi). It also included two particulate filters, a 35 SCFM refrigerated air dryer, regulator, control solenoids, pressure switch, control valve, and a mass flow meter that was linked to the PLC. Air is transferred to Trailer #2 via flexible hose. A secondary airline with a regulator is also included to provide venting of the lower explosive limit (LEL) sampling line in Trailer #2 during non-injection periods.

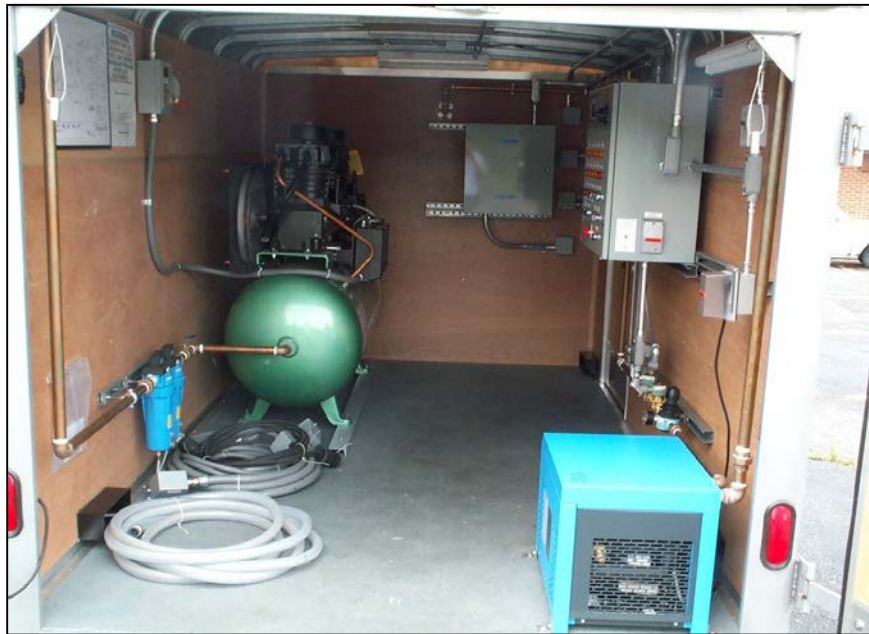
Figure 5.3. Inside of Trailer #1 – Controls and Air Supply System.

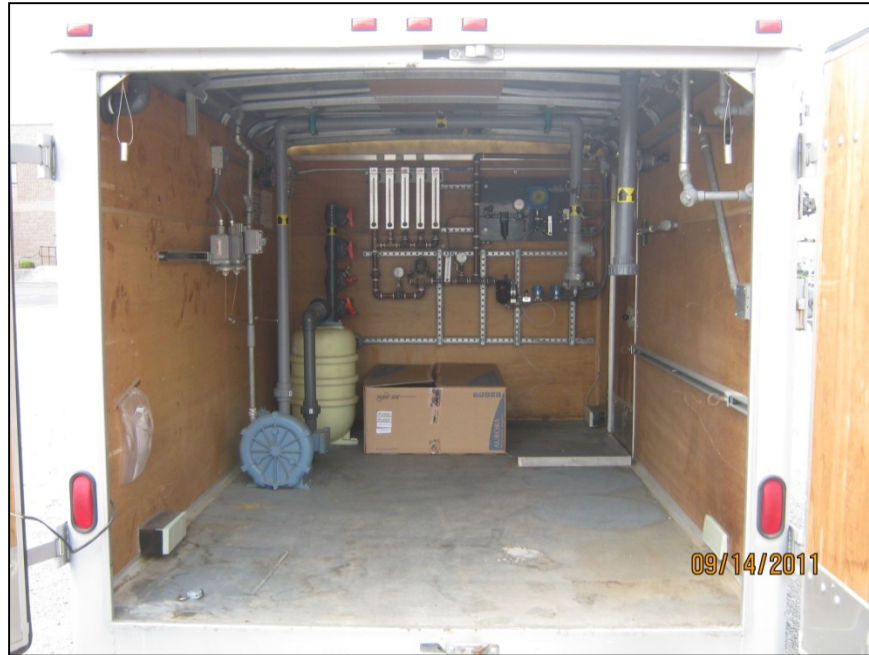
Figure 5.4. Inside of Trailer # 2 – Propane Feed, and Distribution and SVE Equipment.

Trailer #2 (**Figure 5.4**) is electrically wired for an explosion-proof atmosphere. The trailer consists of a propane feed system, air/propane distribution system, and a soil vapor extraction (SVE) system (the SVE system was not utilized during this demonstration). The propane feed system consists of an external propane cylinder with regulator that transfers propane to the air/propane distribution system through a pressure switch to redundant solenoid control valves, through a flow indicator with a switch and ball valve. The propane joins the air feed downstream of its pair of check valves. The Propane Injection Panel Assembly is intrinsically safe and in full compliance with the liquefied petroleum (LP)-Gas Code, with barriers inside the main control panel.
